CALIFORNIA DIVISION OF MINES AND GEOLOGY

Fault Evaluation Report FER-26

March 7, 1977

1. Name of fault: Arroyo Parida fault (eastern segment) and Santa Ana fault.
2. Location of fault: Ojai, Matilija and White Ledge Peak 7.5' quadrangles, Ventura County; this fault extends westward into Santa Barbara County (see FER-3).

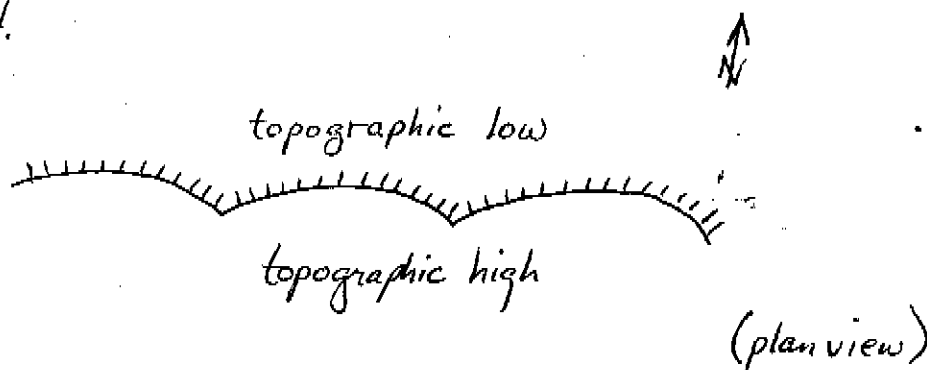
Figure 4.

But in reality, the escarpment noted on plate 4 is "convex" with the "intersections" pointing away from the topographic low (figure 4).

Thus, one can conclude that this escarpment is due to other than stream erosion. One possibility is that this feature could be the result of a very low angle thrust fault, up on the south (which is at least the correct sense of movement for both the Arroyo Parida and Santa Ana faults). [TCS NOTE: I must admit that I have not reviewed these photos since developing this hypothesis, and I am not certain that anyone else looking at these photos would come to the same conclusions. These photos should be looked at again to determine whether this hypothesis really has merit.]

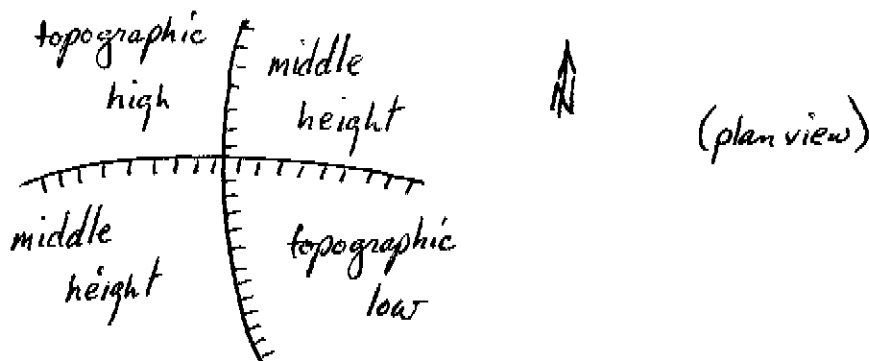
Figure 7.

However, the south segment of the old stream bank was not obliterated, therefore, the east-west scarp must be due to other causes (such as faulting) (see figure 7).

Unfortunately, it is impossible (by this deductive reasoning) to determine which scarp was produced first and, therefore, which scarp is due to other causes (faulting). However, this feature lies along the trace of the east-west trending Arroyo Parida and Santa Ana faults and thus, may be the surface expression of these faults. One problem, however, lies in the fact that the northern block is elevated with respect to the southern block and thus, indicates movement in the opposite direction of all other data. For a further description of this feature, see item 7.
